Corrosion in the Petroleum Industry

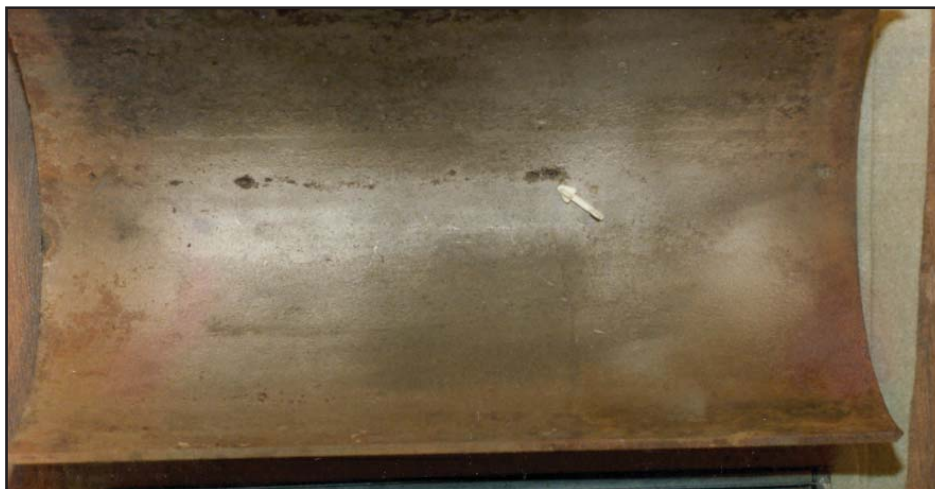
Figure IV-9: MIC Detected in the 3 o'clock Position

In most cases, MIC attack occurs at the bottom of the line where water accumulates. However, MIC has also been detected in the 3 o'clock to 9 o'clock position, where there was a possible water and oil interface (Figure IV-9 and Figure IV-10).

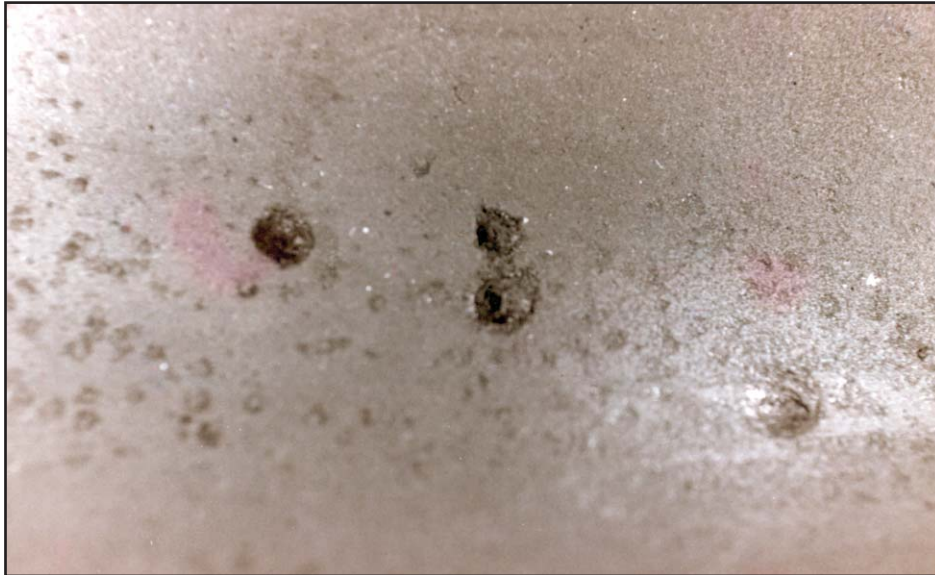
Figure IV-11: Detectable Black Growth

One of the failures had detectable black growths, which tested positive for SRB, and had corrosion pits beneath the growth (Figure IV-11).

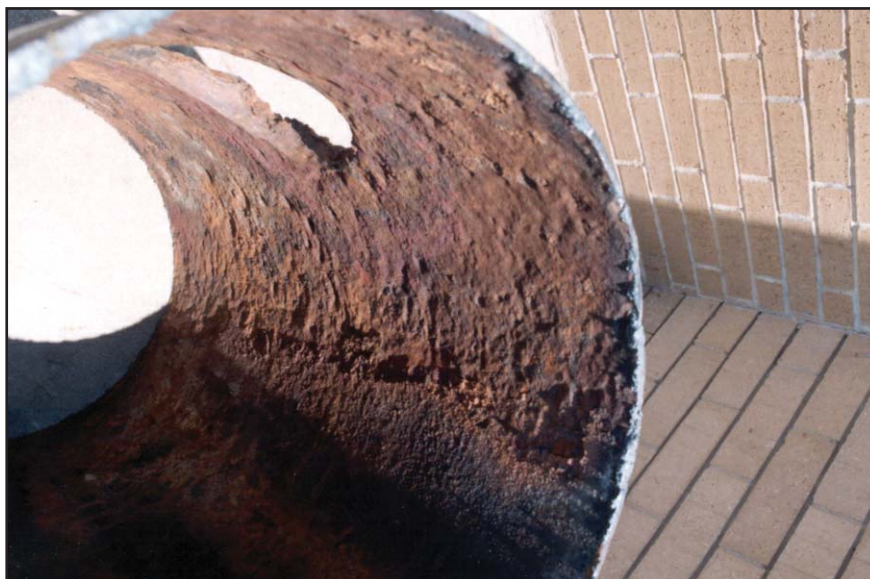
Figure V-1: Hydrochloric Acid and Hydrogen Sulfide Corrosion

Figure V-1 shows an example of hydrochloric acid and hydrogen sulfide corrosion. This sample of a carbon steel overhead line came from a horizontal section of the overhead system. The top half of the line had severe metal loss in the form of pitting and generalized corrosion. The bottom half of the line showed no corrosion.

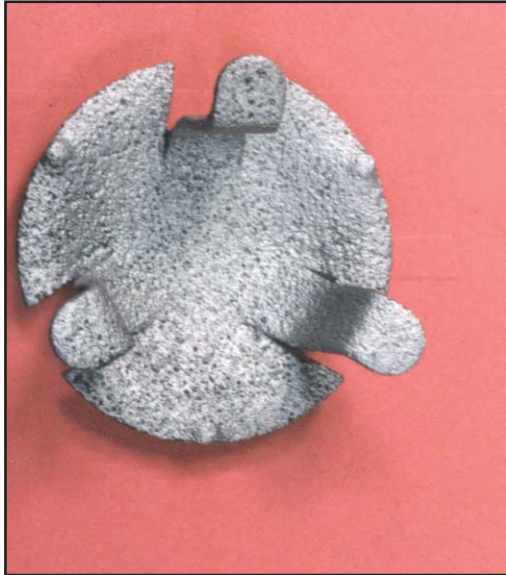
Possible causes of corrosion in these caps are hydrogen sulfide and ammonium chloride deposits (Figure V-3 and Figure V-4).

Figure V-3: 13 Cr Stainless Steel (UNS410) Bubble Cap Corrosion

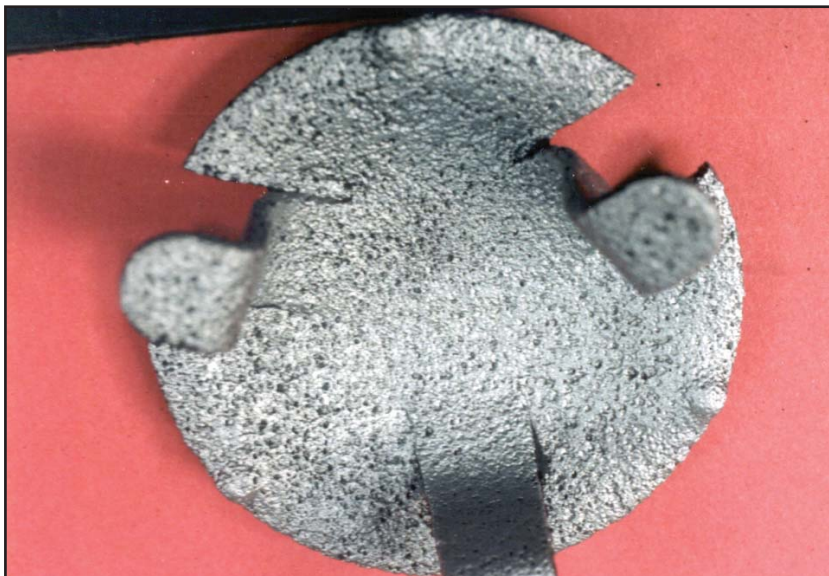
Figure V-4: Close-up of Pitting Corrosion

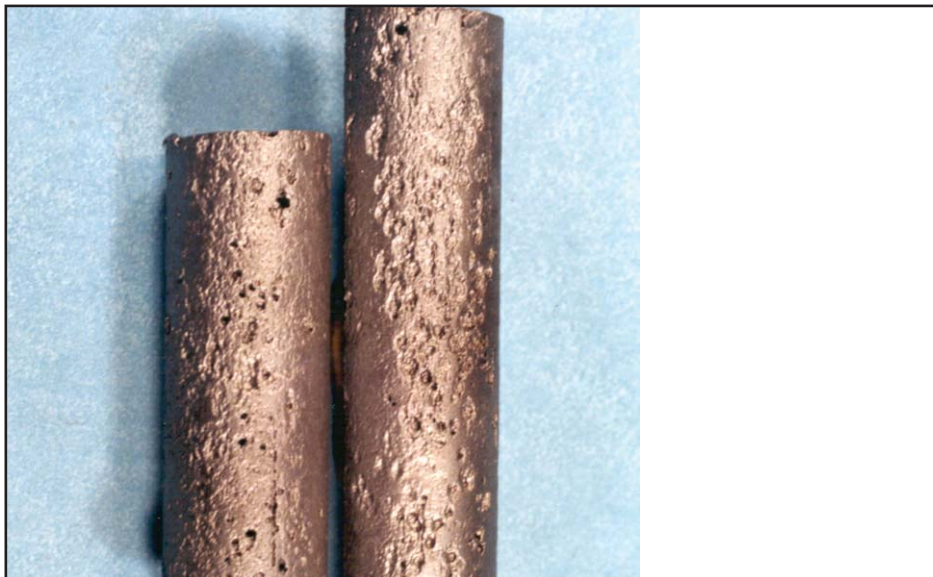
Figure V-5 shows an example of ammonium chloride underdeposit corrosion.

Figure V-5: Ammonium Chloride Corrosion on Carbon Steel Heat Exchanger Tubes

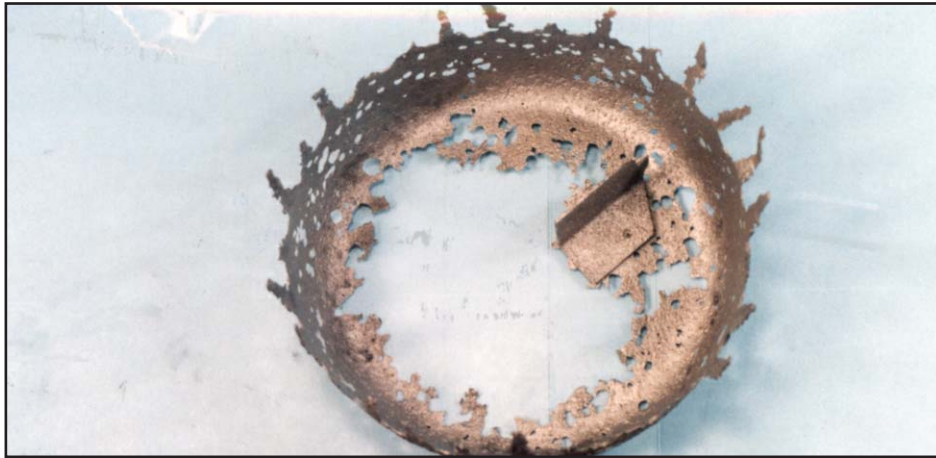
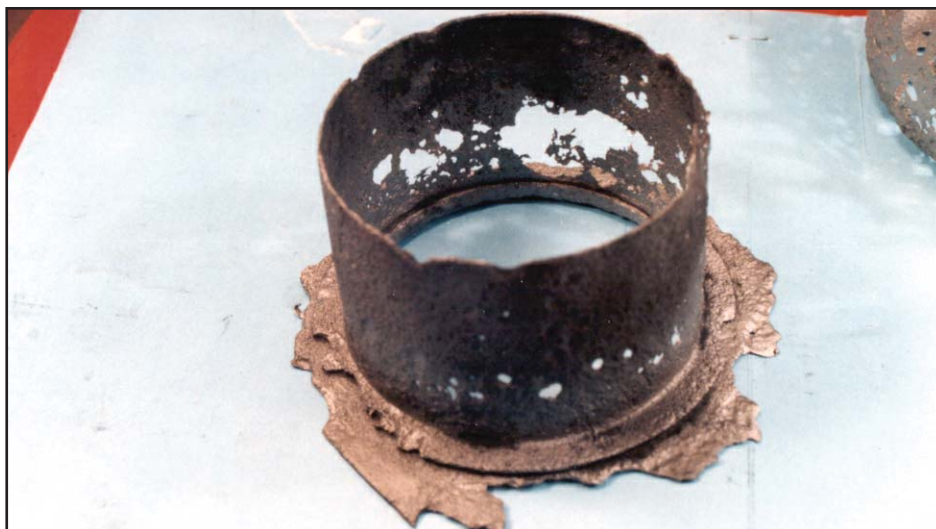
Figure V-7 and Figure V-8 show SS410 (13Cr) tray cap parts that are severely deteriorated by ammonium chloride, and the hydrogen sulfide that formed the metal sulfides found on the surface after the alloy had been degraded.

Figure V-7: Ammonium Chloride Corrosion on SS410 Trays

Figure V-8: Ammonium Chloride Corrosion on SS410 Trays

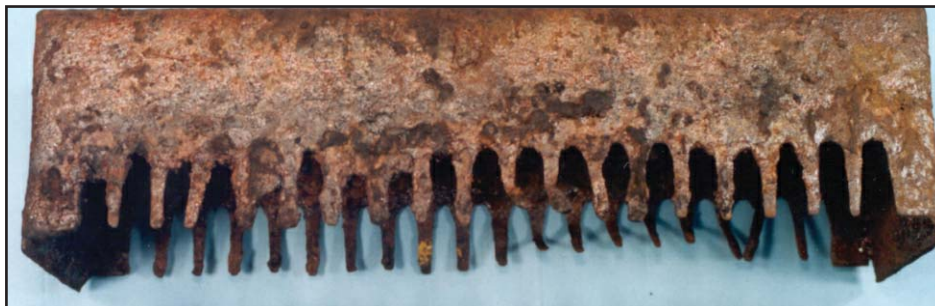
Figure V-11 and V-12 is an example of underdeposit corrosion by chlorides, sulfides, and ammonia.

Figure V-11: Carbon Steel Trays — HCl Corrosion

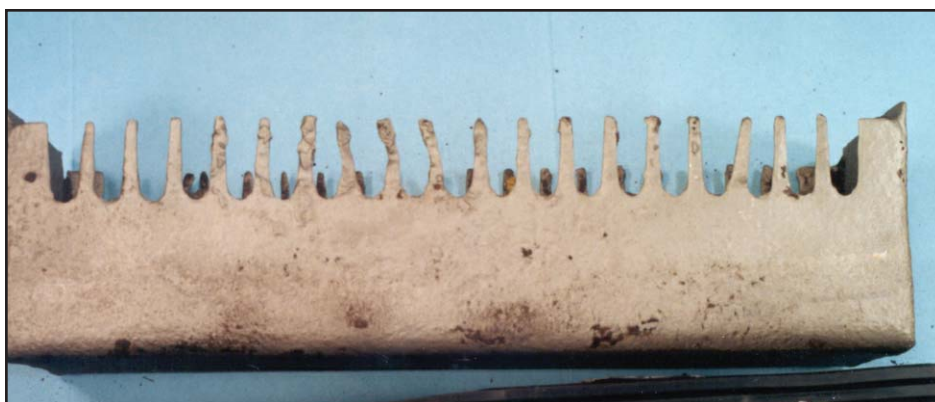
Figure V-12: Underdeposit Corrosion — Note the thinning cleaned surface

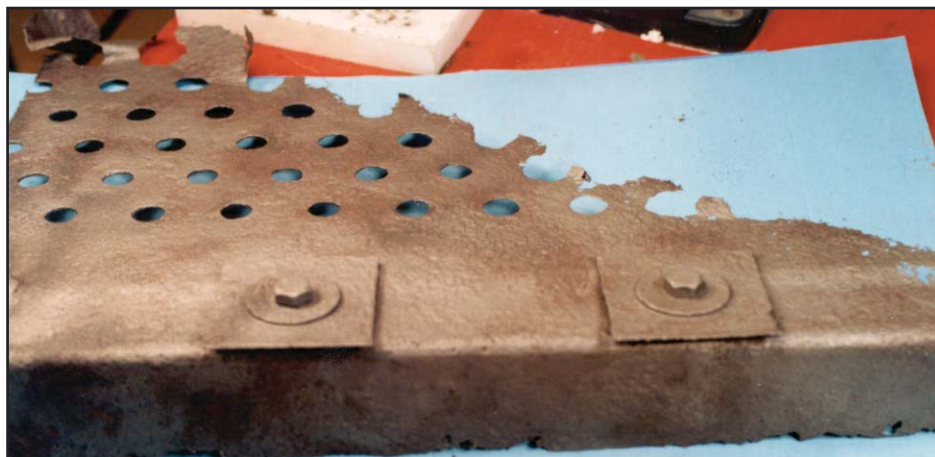
Figure V-13 shows a carbon steel upper tray with an orange peel corrosion pattern. Deposits indicate corrosion mechanisms could have been sulfidation, oxidation, or ammonium chloride.

Figure V-13: Sulfidation/Oxidation or Ammonium Chloride

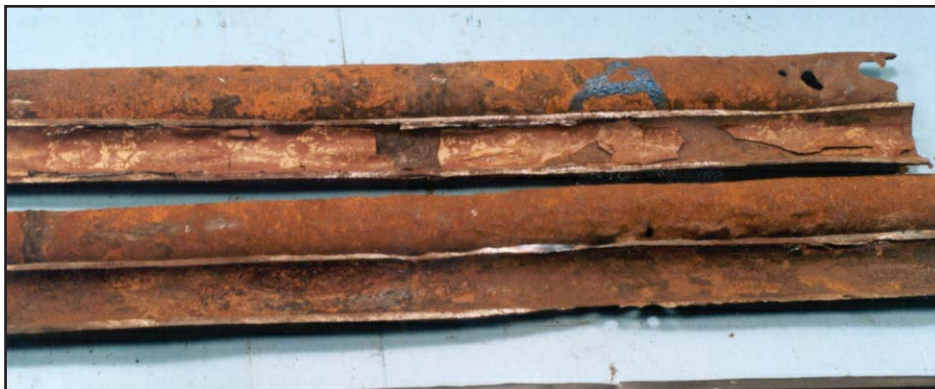
Figure V-14 shows an example of a carbon steel heat exchanger tube in pre-flash overhead with external underdeposit corrosion.

Figure V-14. Underdeposit Corrosion

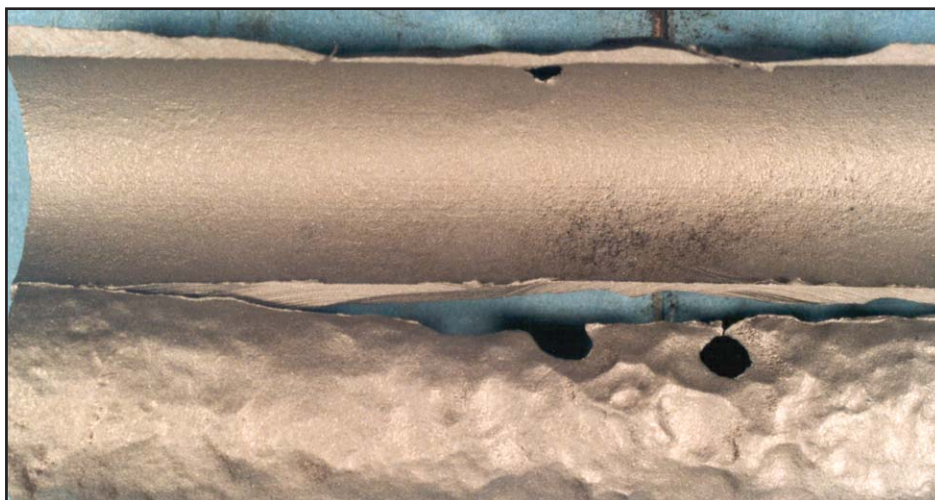
In Figure V-15, pitting and gouging are most likely from acid penetration of fouled surface. Note the internal surface showed no corrosion.

Figure V-15: Pitting and Gouging - External Surface

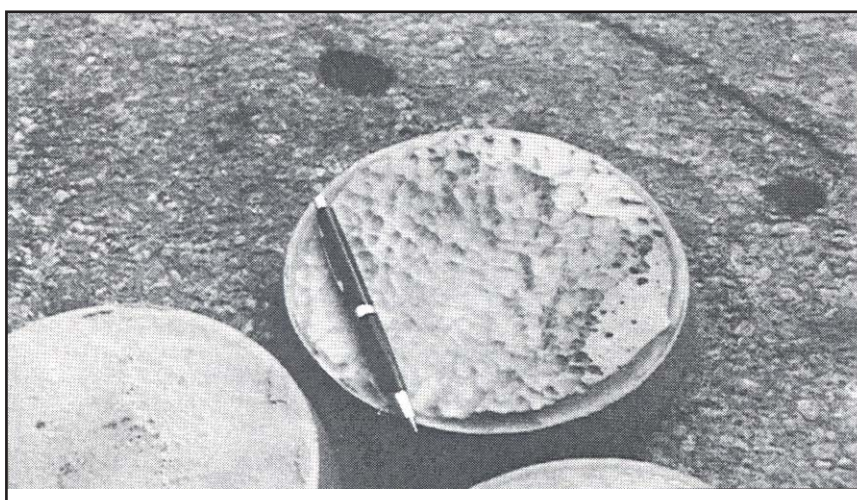
Figure VI-2: Typical Pitting From Naphthenic Acid Corrosion on Heater Plugs

Upgrade in metallurgy or corrosion inhibitor required to resist naphthenic acid corrosion (Figure VI-2).

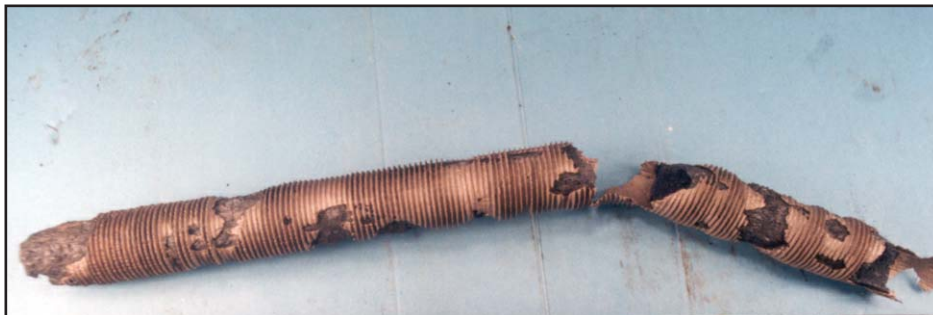
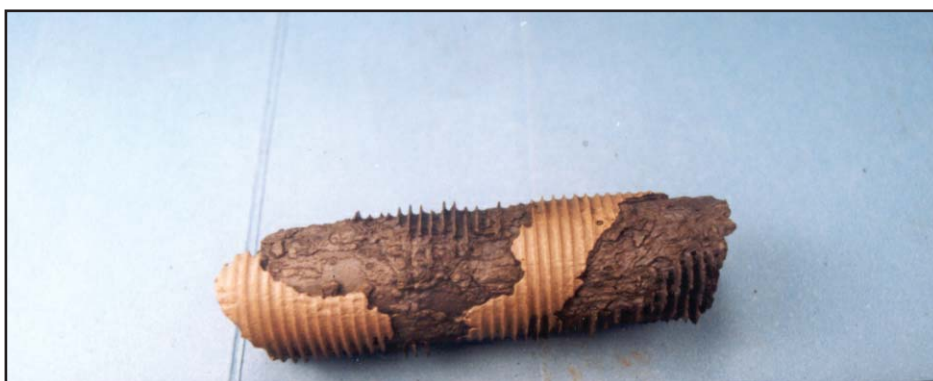
Figure VII-1 and Figure VII-2 show an example of hydrogen sulfide attack on 90Cu-10Ni tubes leading to failure.

Figure VII-1: De-alloying Tubes — H₂S Corrosion 90-10 Cu:Ni Heat Exchanger Tubes

Figure VII-2: Close-up of De-alloying Tubes — H₂S Corrosion 90-10 Cu:Ni Heat Exchanger Tubes

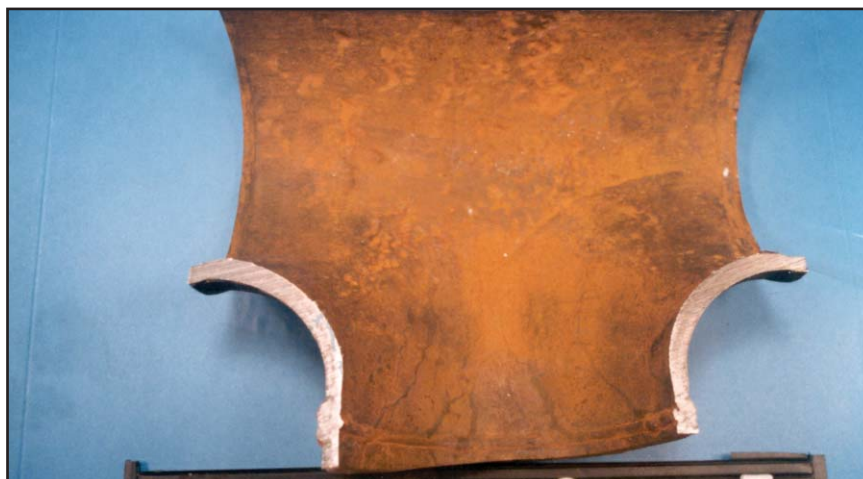
Figure VIII-1 shows an example of a carbon steel tee showing signs of erosion corrosion. The horseshoe-shaped pits indicate the direction of flow.

Figure VIII-1: Erosion Corrosion — Carbon Steel Tee

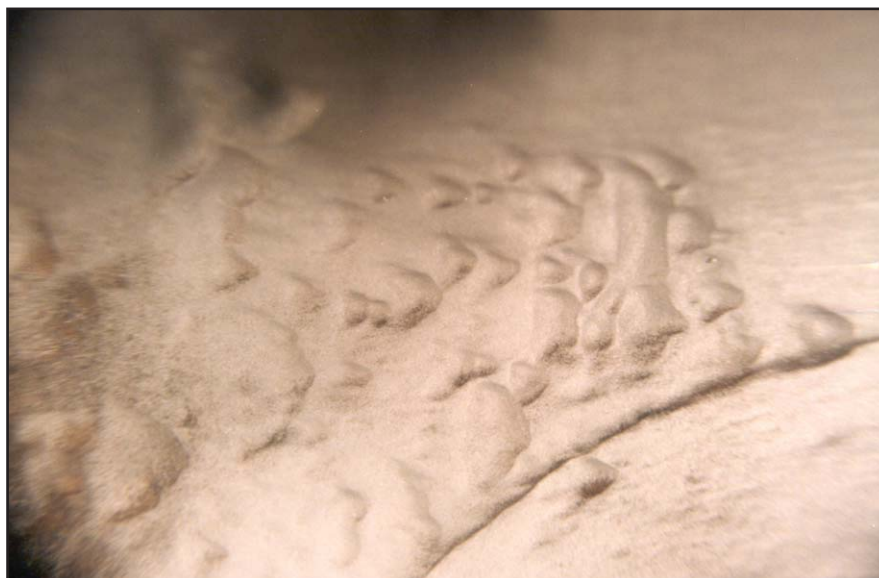
Figure VIII-2: Close-up Pits after Cleaning

Figure VIII-2 shows a close-up of the pits after cleaning. Corrosion by-products in the pits suggest the corrosive agents were ammonium chloride and hydrogen sulfide.

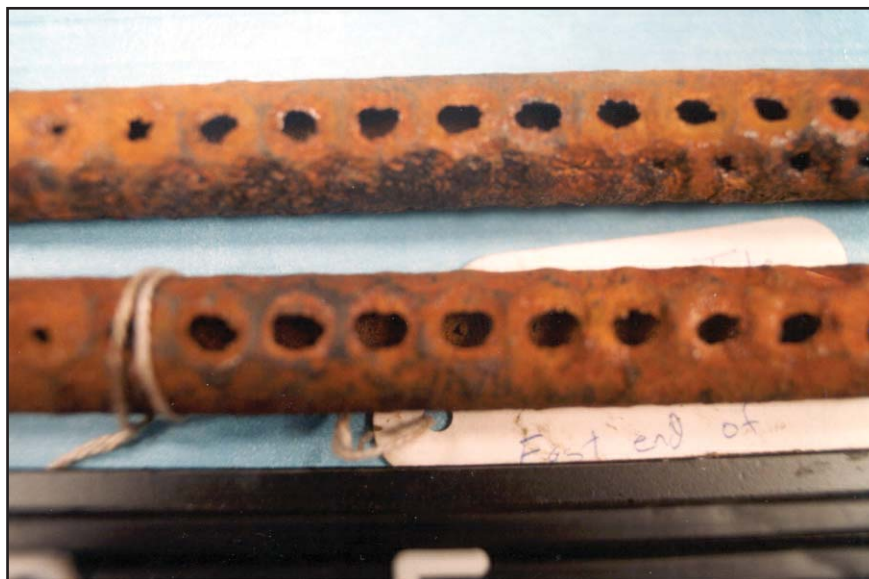
In this example of erosion-corrosion, fluids are channeled through the perforations in the diffuser plate, causing localized impingement sites. FeS film is continually eroded off, replaced, and eroded off again (Figure VIII-3).

Figure VIII-3: Erosion-Corrosion — Carbon Steel Overhead Exchanger Tubes

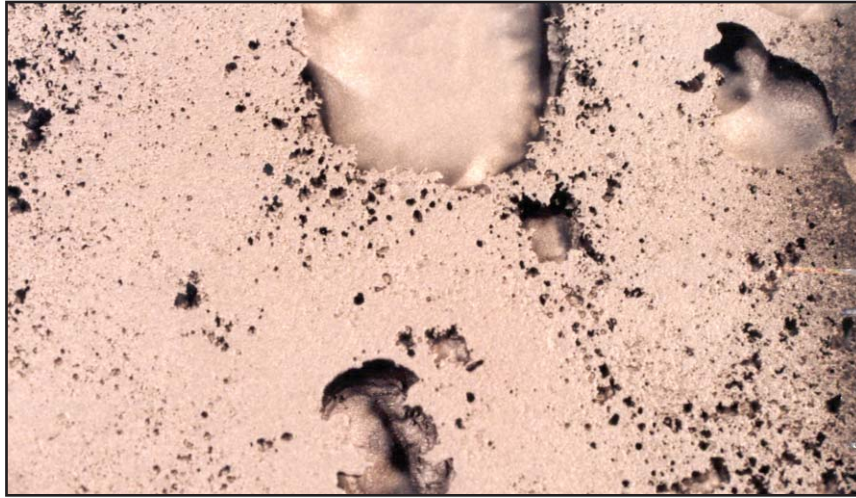
Metal loss was confined to a DEA impingement zone. Corrosion was attributed to carbon dioxide in the DEA (Figure VIII-4).

Figure VIII-4: Erosion-Corrosion — DEA Stripper Tower Wall

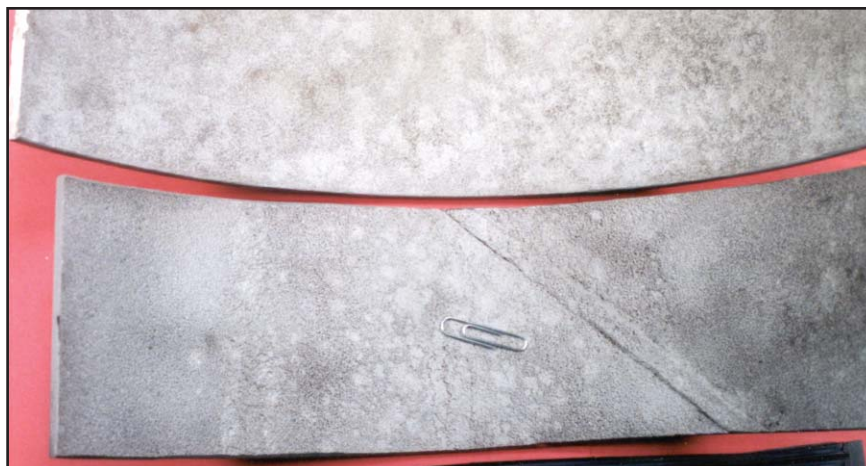
Underdeposit etching was attributed to sulfur containing species and oxygenated fuel in transported fuels (Figure VIII-8 and Figure VIII-9).

Figure VIII-8: Carbon Steel Product Pipeline Corrosion

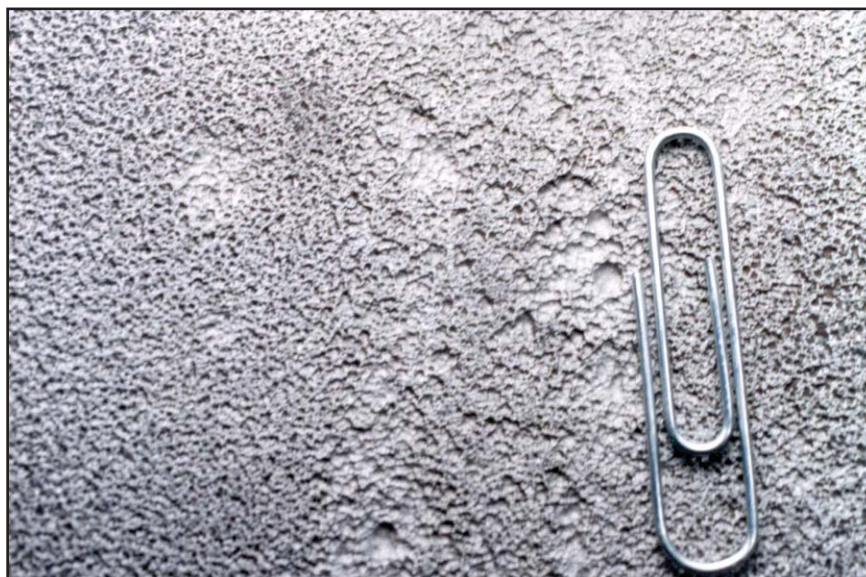
Figure VIII-9: Close-up of Carbon Steel Product Pipeline Corrosion

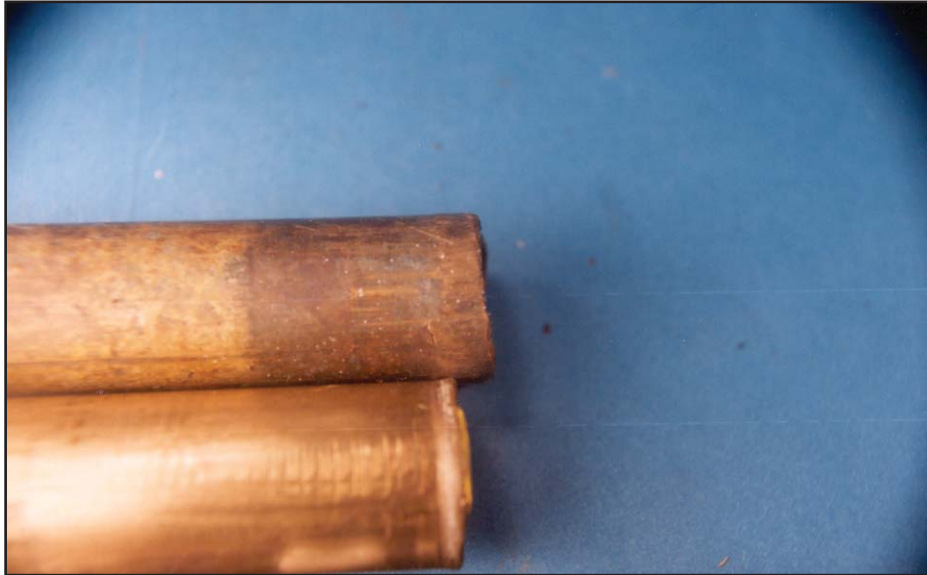
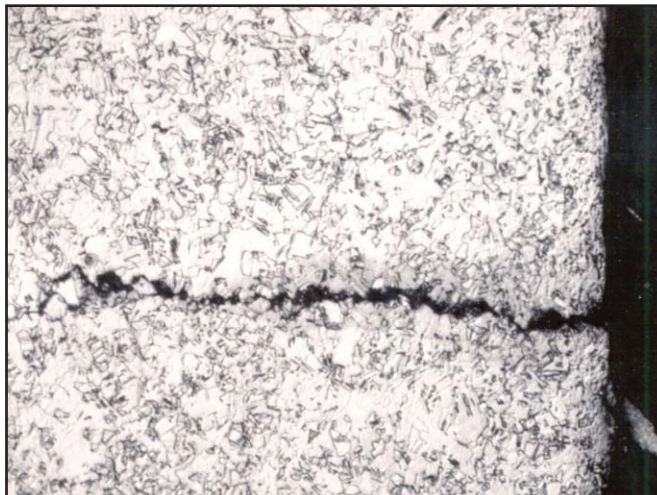
Aluminum brass crude overhead heat exchanger tubes show signs of stress cracking (Figure VIII-10 and Figure VIII-11). There was no evidence of corrosion affecting the tubes. Therefore this was probably due to:

- Tubes overstressed during installation.
- Thermal stressing during hydrotest and operations.
- Operational stresses, such as water, hammering, and vibration.

Figure VIII-10: Aluminum Brass Stress Cracking

Figure VIII-11: Aluminum Brass Stress Cracking

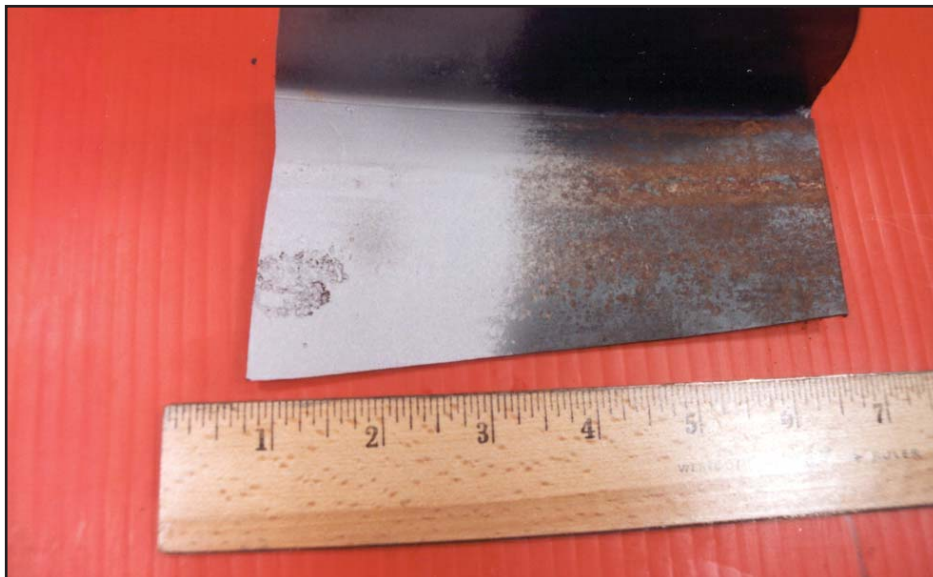
Figure VIII-15 and Figure VIII-16 shows an example of corrosion by pitting at the water layer in the bottom of diesel steel storage tanks. Possible mechanisms for pitting include microorganism influenced corrosion and/or galvanic corrosion due to sulfide inclusions in the steel.

Figure VIII-15: Fuel Storage Tank Corrosion

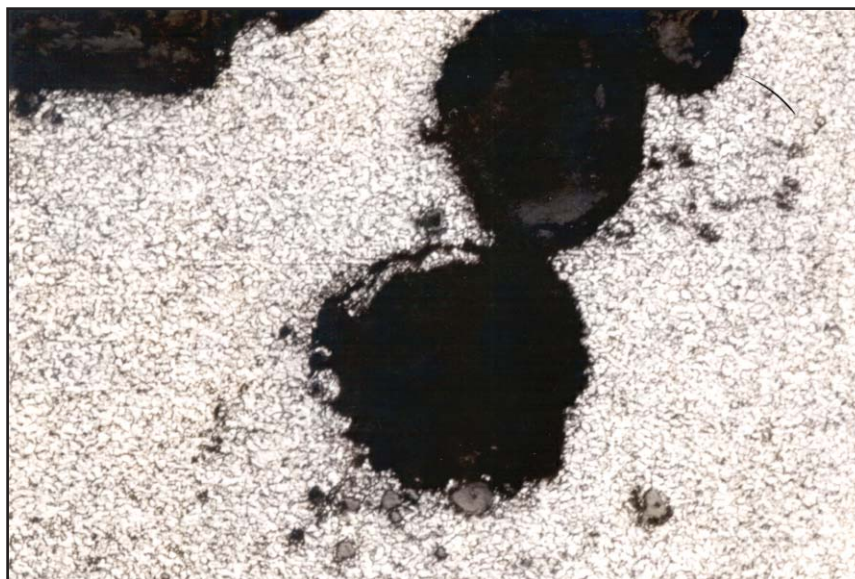
Figure VIII-17 is a photomicrograph at 100X showing the cavernous pits, carbides, and manganese sulfide stringers.

Figure VIII-17: Fuel Storage Tank Corrosion

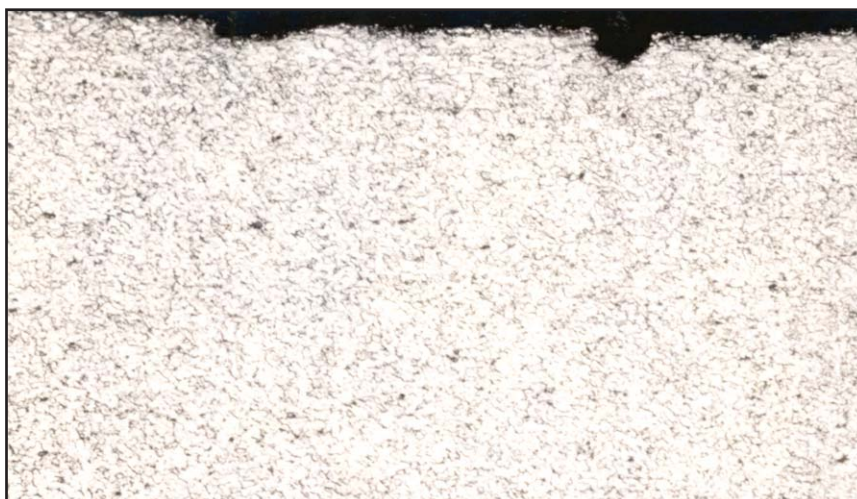
Figure VIII-18 shows another section of the bottom of the fuel tank where corrosion had not occurred. Note the relative cleanliness as compared to figure VIII-17.

Figure VIII-18: Fuel Storage Tank Corrosion

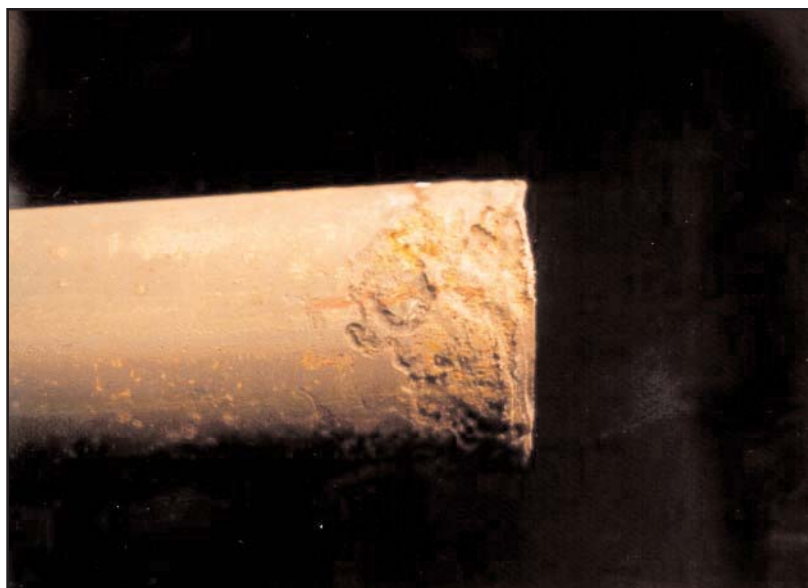
Deep, localized wastage occurred at the ends of several tubes at the bottom of a transfer line exchanger, causing two failures (Figure IX-1). Thick layers of deposits accumulated on the bottom tubesheet of this exchanger (Figures IX-2 and Figure IX-3). These deposits insulated the tubes and tubesheet, and prevented the rinsing away of caustic and other aggressive alkaline salts following steam generation. The alkaline salts concentrated to levels as high as the percent ranges to remove protective iron oxide layers and to attack the steel.

Figure IX-1: Localized Metal Loss at End of Tube that Contacted Bottom Tubesheet

Clean and maintain clean tubesheet surfaces. Alter the design and operation of the exchanger to prevent the formation and entrapment of a steam blanket. Since no corrosion occurred away from the tube ends, boiler water chemistry and treatment was proper and did not contribute to the corrosion.

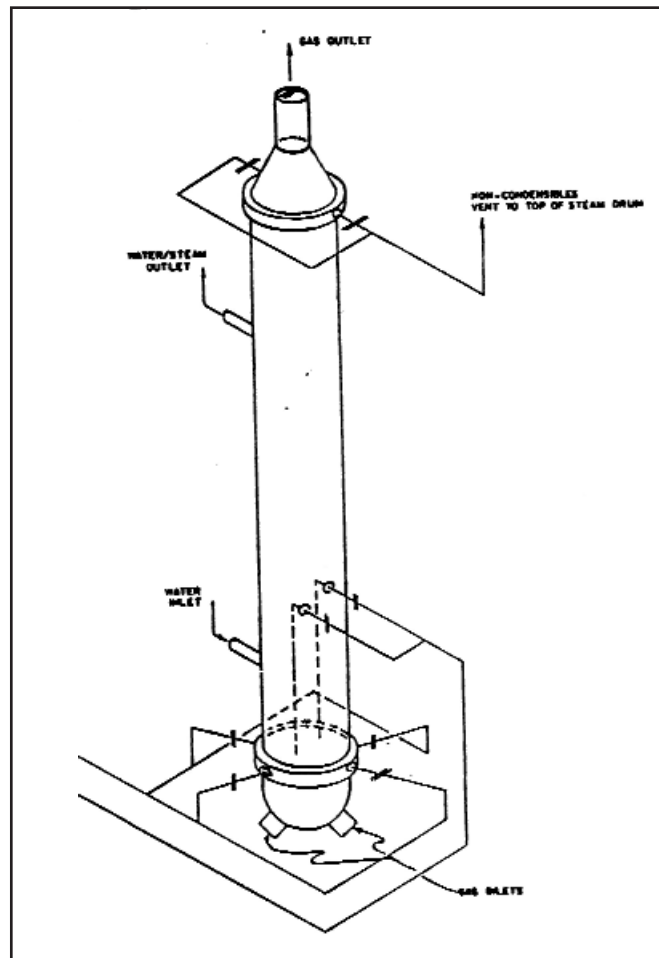
Figure IX-2: Transfer Line Exchanger

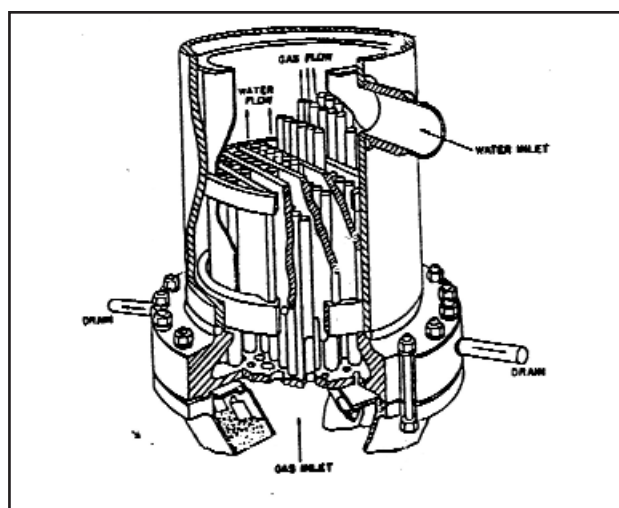
Figure IX-3: Tubesheet where Corrosion Occurred

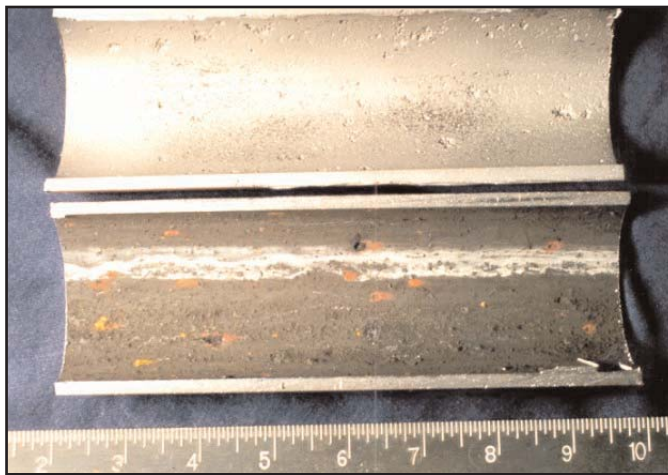
A tube section was removed from the generating bank for surveillance. The internal surface of the section was generally covered with thin, uniform layers of black iron oxides and deposits (Figure IX-5). The uniform layers were interrupted in scattered sites by mounds or tubercles of black iron oxide (Figure IX-6). The presence of iron oxide tubercles indicated that oxygen corrosion occurred at the tubercle sites, resulting from exposure to waters containing excessive concentrations of dissolved oxygen. Removing the layers and tubercles revealed a mostly smooth, unattacked internal surface that was interrupted by moderately deep depressions where the tubercles were present (Figure IX-7).

Figure IX-5: Bottom-half Section Showing Internal Surface Covered with Uniform Layer of Black Iron Oxide Interrupted by Scattered Iron Oxide Tubercles

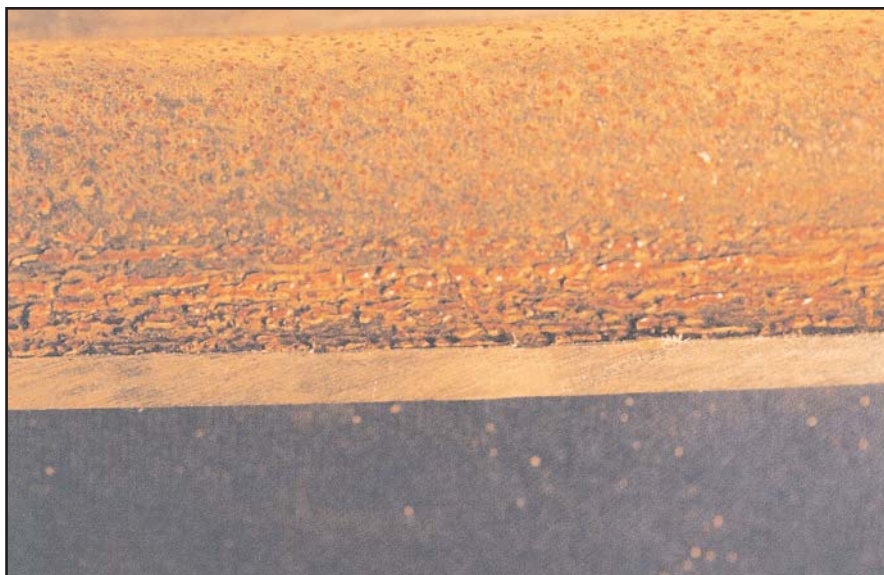
In some cases, idle time oxygen corrosion may be identified by the pattern and nature of iron oxide formation. Figure IX-8 shows the internal surface of a horizontally-oriented economizer tube that experienced shallow metal loss within narrow strips along the bottom. During idle periods the boiler was drained and a shallow pool of water remained along the tube bottom. Air leaked into the boiler and oxygenated the residual water to cause oxygen corrosion that produced orange-brown iron oxide corrosion products.

Figure IX-8: Localized Strip of Orange-brown Iron Oxide along bottom of Horizontal Tube

Idle time oxygen corrosion may be controlled through use of proper lay-up practice. This may include inert gas (nitrogen) blanketing and the proper use of oxygen scavenging chemicals. Such chemicals may be fed to higher levels than used during boiler operation, and may require monitoring, replenishment and circulation. Oxygen corrosion during boiler operation requires proper feedwater deaeration and oxygen scavenging practice.

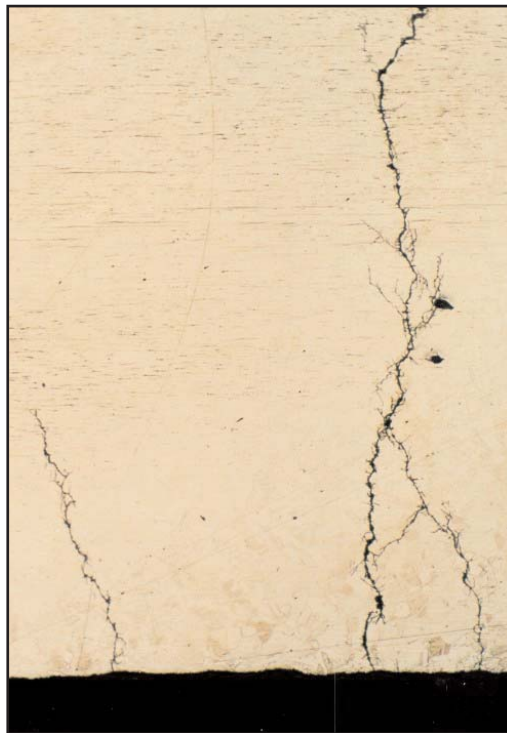
Metallographic cross-sections revealed that the cracks were transgranular, highly branched and penetrated from the internal surface outward (Figure IX-16). This revealed that the fissures and cracks formed due to stress corrosion cracking.

Figure IX-16: Metallographic Cross-section Revealing Branched, Transgranular Cracks Penetrating Outward from Internal Surface

The most probable corrodent responsible for stress corrosion cracking was determined to be chloride for several reasons.

- 1) The threshold concentration of chloride necessary to cause cracking may be quite low at the normal operating temperatures of the deaerator. Cracking may occur at chloride concentration as low as 20 ppm at 200°F (93°C).
- 2) Caustic stress corrosion cracking rarely occurs at metal temperatures below 300°F (149°C) and generally requires concentrations of caustic in the percent levels. It is improbable that either condition was met in this system.
- 3) The presence of depressions and oxide corrosion products on the internal surface would have formed due to corrosion by chloride. Caustic would not tend to cause such corrosion.

Since chloride stress corrosion cracking may occur at even low concentrations at normal operating temperatures, it is recommended that deaerators and water-wetted components throughout boilers should not be constructed of austenitic stainless steels. Aside from this recommendation, chloride stress corrosion cracking may be prevented only by ensuring that no chloride gets into the deaerator, which will be very difficult and expensive to accomplish.

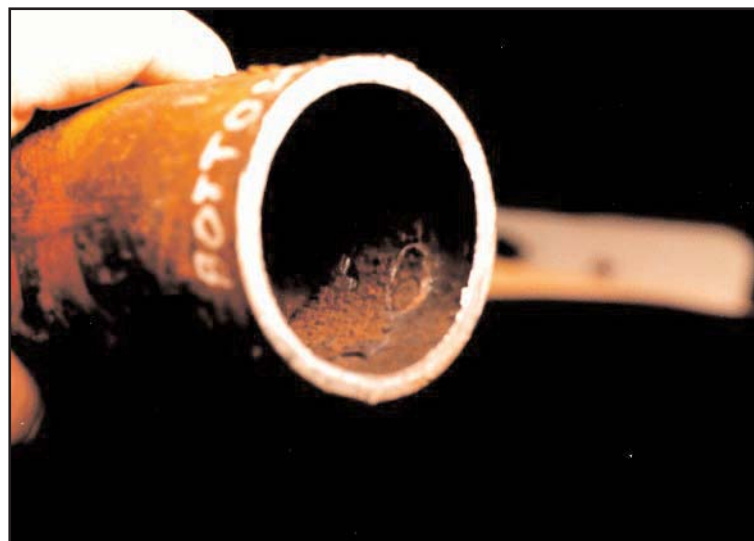
Two bulges formed within a localized area on the hot side of a boiler wall tube (Figure IX-17). The bulges occurred in a tube that was located near a burner. Internal deposition was light in all areas except at the bulges (Figure IX-18).

Figure IX-18: Localized Deposition at Bulge Site

All of the microstructural features at the bulges indicated that the tube wall at the bulge sites experienced mild, long-term overheating. Metal temperatures ranged from about 850° to 1,100°F (454° to 593°C) for a period ranging from several weeks to several months. Metals have decreased strength at high temperatures (Figure IX-22). Consequently, the tube wall bulged under stresses supplied by internal pressure. The localized nature of the bulging and internal deposition indicated that overheating was caused by excessive fireside heat input.

The most practical method of controlling overheating in this case would be through proper insulation of the external surfaces of the tubes in the location where the bulges formed. This may be provided by installing refractory or repairing damaged refractory at that location. If this cannot be accomplished, then excessive heat input should be prevented by decreasing firing rates and preventing localized channeling of hot gases to the zone of the bulged tube.

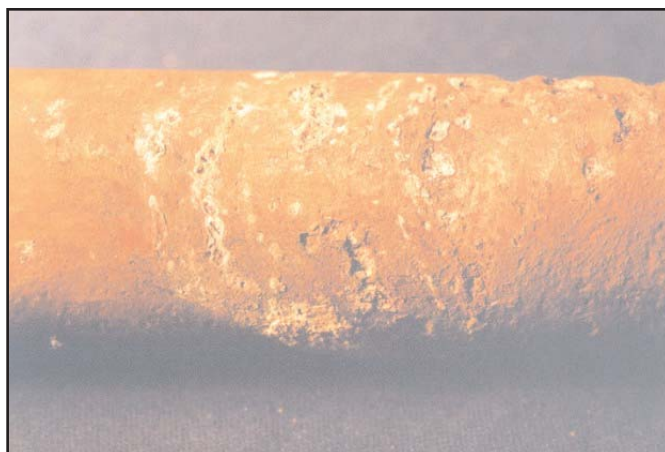
Numerous deep depressions formed on the external surfaces of several different economizer tubes (Figure IX-23). Thick layers and mounds of light-colored deposits covered the depressions and surfaces in the surrounding areas. Deep depressions were found beneath adherent deposits (Figure IX-24). These deposits tested acidic in a distilled water solution. Chemical analysis of the deposits revealed the presence of high concentrations of sulfate and volatile sulfur compounds. The presence of these deposits indicates that the fireside corrosion may have been caused in part by the condensation of sulfuric acid on the surfaces. When high sulfur content fuels are combusted, the sulfur is oxidized to sulfur trioxide, which combines with moisture in the furnace environment to form sulfuric acid.

Figure IX-23: External Surface Depressions and Acidic, Light-colored Deposits

- 1) Maintaining metal temperatures above the sulfuric acid dewpoint.
- 2) Reducing moisture content (lower moisture content fuels and minimization of soot-blowing).
- 3) Altering firing practice, by combusting fuel with lower excess air.
- 4) Feeding fuel treatment additives.

- 1) Removing corrosive acidic fireside deposits with high pressure water sprays followed by rinsing with a neutralizing lime wash spray.
- 2) Maintaining a dry fireside environment with the aid of dessicants.

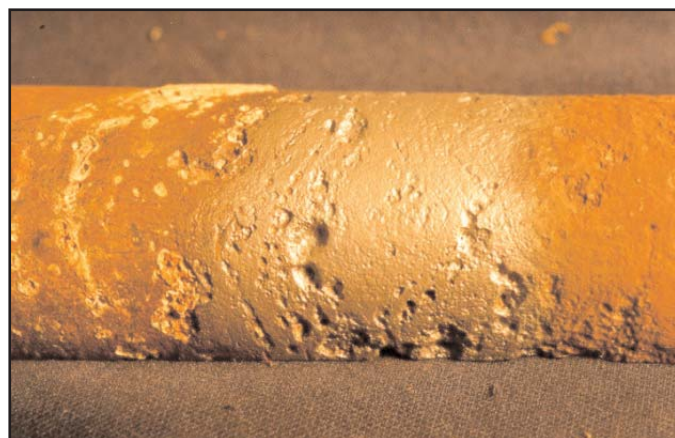
Figure IX-24: Deposits Removed to Reveal Depressions

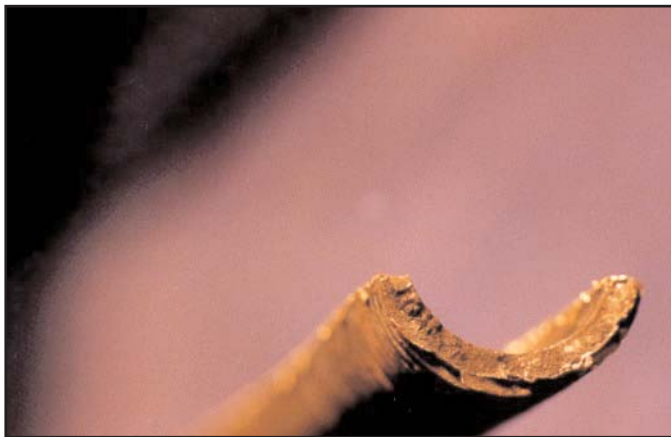
Approximately 200 heat exchanger tubes within the unit experienced sudden cracking failures (Figure IX-27). Metallographic analysis revealed the presence of deep, highly branched, intergranular cracks that penetrated from the internal, waterside surface (Figure IX-28). This mode of crack propagation is characteristic of stress corrosion cracking. Stress corrosion cracking of metals results from exposure to specific corrosives for the particular alloy while being subjected to applied and/or residual stresses. Residual stresses are supplied by original tube forming operations.

Figure IX-27: Wall of Admiralty Brass Heat Exchanger Tube Penetrated by a Crack

The specific corrodents that most commonly cause stress corrosion cracking of admiralty brass are ammonia and hydrogen sulfide. These corrodents were considered as possible causes for the cracking. However, analysis of deposit and corrosion product layers that covered the internal surface revealed the presence of significant amounts of mercury compounds. Mercury causes rapid intergranular cracking of copper alloys in a manner similar to stress corrosion cracking, a mechanism referred to as liquid metal embrittlement. The rapidity of the failures and the intergranular propagation of the cracks more significantly implicate mercury as the corrodent. The presence of mercury is highly unusual in cooling water and could only have been introduced due to contamination. One possible source of mercury is from a pressure-measuring device.

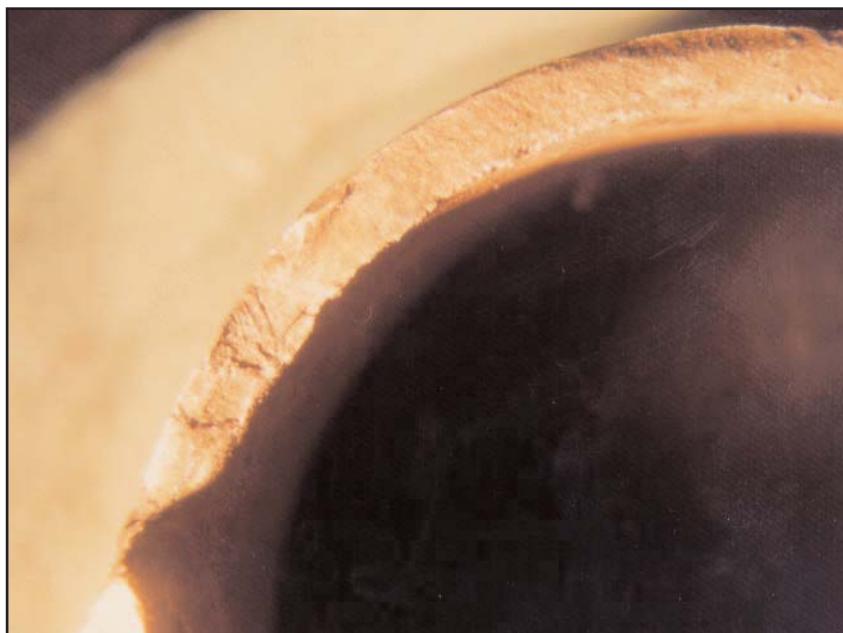
A crack-like failure occurred in a surface condenser tube (Figure IX-34). Scattered depressions formed on the internal surface (Figure IX-35). Metallographic analysis revealed that the surfaces of the depressions were covered with layers of metallic copper, indicating that dezincification, a form of dealloying, occurred (Figure IX-36). Dezincification occurred beneath occlusive deposit layers due to the concentration of chloride from the water solution by an ion concentration cell mechanism. The corrosion caused zinc to be preferentially removed from the copper-zinc matrix of the alloy. This left behind a weak, porous mass of pure copper on the corroded surface.

Figure IX-34: Cracking Failure

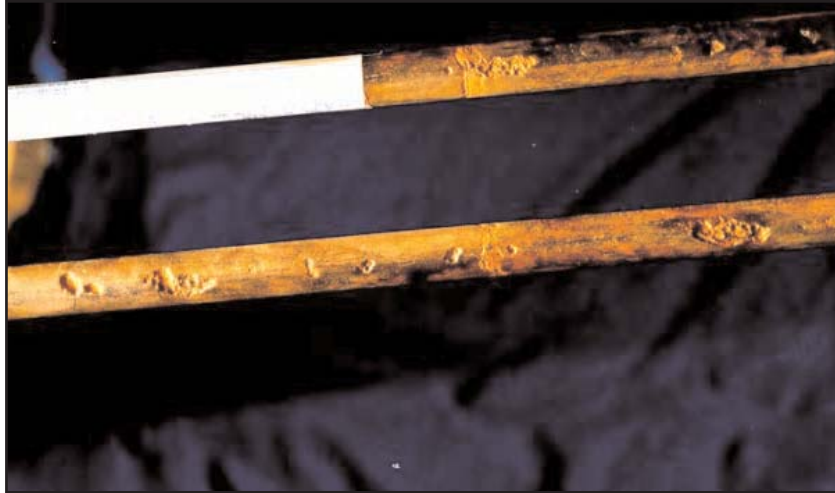
Clusters of mutually intersecting, deep depressions formed in scattered spots on the external surfaces of several tubes in the exchanger (Figure IX-38). The depressions were hemispherical in shape. In some locations, the depressions mutually intersected (Figure IX-39). The depressions were lined with iron sulfide corrosion products (Figure IX-40). It was reported that a gooey slime layer covered the external surface when the bundle was removed. Bacterial counts on tube surfaces were 5 million CFU/ml total, with 8,000 CFU/ml of sulfate reducing bacteria.

Figure IX-38: Scattered, Deep External Surface Depressions

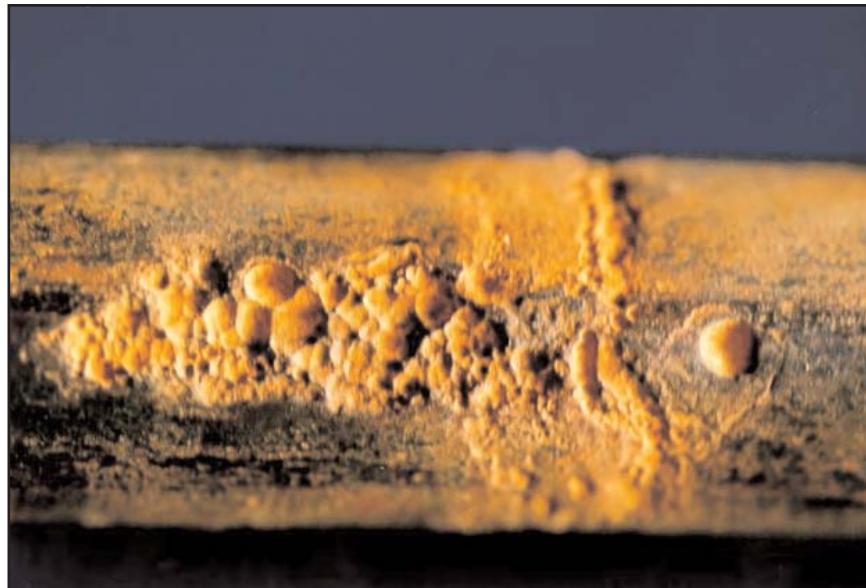
Figure IX-39: Clusters of Mutually-intersecting, Rounded Depressions

In any failure analysis investigation, all four factors listed below are required to positively confirm a case of microbiologically influenced corrosion. In this case, all four factors were identified to confirm that corrosion was caused by sulfate reducing bacteria.

- 1) The presence of microorganisms — Confirmed by high bacteria counts.
- 2) Unique corrosion morphology — Hemispherical depressions, some in clusters.
- 3) Specific corrosion products and deposits — Sulfide layers lining the depressions.
- 4) Compatible environmental conditions — Sulfate reducing bacteria are anaerobic.

Sulfate reducing bacteria reduce sulfate ions to sulfide in their biological process. One of the more popular proposed mechanisms to explain how these bacteria promote corrosion is through removal of hydrogen, which depolarizes the cathode in the corrosion cell. Sulfate reducing bacteria are anaerobic, so they live and grow beneath occlusive layers of deposits and slime. Slime also promotes the growth of anaerobic bacteria by depleting oxygen.

Microbiologically influenced corrosion may be controlled through use of adequate concentrations of proper biocides that are fed in a proper manner. Low (< 3 ft/s) or stagnant (<1 ft/s) flow should be minimized or prevented. Clean metal surfaces should also be maintained. In this case history, flow rates were low, since cooling water flowed across the shell sides of the tubes. In addition, slug feed of biocide was inadequate for the system.
